Steven Stone,¹ M.S., Margaret Barber,² M.S., Ronald Wojciechowski,³ B.S., and Paul Martin,⁴ Ph.D.

Measurement and Variation of UV Absorbers within Multi-Year Samples of Automotive Clear Coat Paint

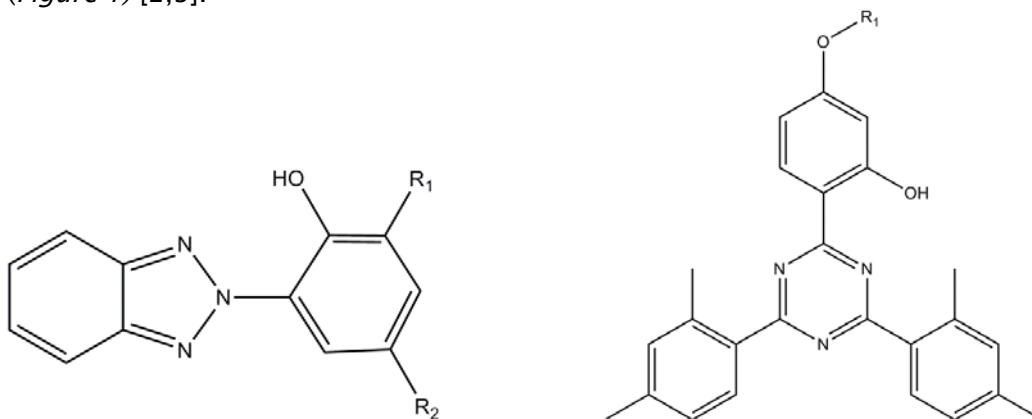
Figure 1 – Example structures of hydroxyphenyl-S-triazines (left) and hydroxyphenylbenzotriazoles (right) [3].

Clear coats have become ubiquitous in automotive paint since their introduction in the early 1970's. In addition to the role of the clear coat in providing protection to the vehicle from nicks and scratches, ultraviolet (UV) light absorbers are also added to protect the color coat from degradation [1,3]. The typical classes of UV absorbers added to clear coats are 2-hydroxyphenyl-S-triazines and 2-hydroxyphenylbenzotriazoles. These compounds are designed to capture UV light and, through photochemical processes, prevent the light from reaching the underlying color coat (Figure 1) [2,3].

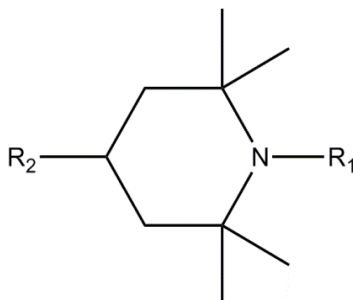
Figure 2 – Example structure of a hindered amine light stabilizer (HALS) [3].

These compounds are generally used along with hindered amine light stabilizers (HALS) to protect the color coats (Figure 2) [3].

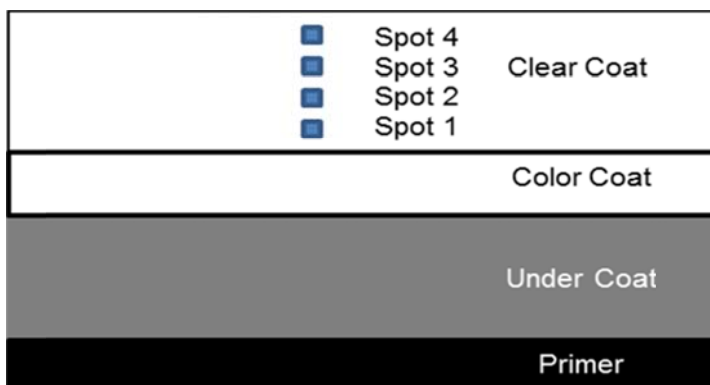
Figure 4 – Example of a paint chip cross-section showing how the clear coat was sampled for MSP analysis within a layer. Spot 1 is closest to the color coat and Spot 4 is closest to the environment.

In order to ensure consistency with regard to the UV absorbers across the various model years, an MSP spectrum was taken from each of the selected samples at an area close to the color coat. This would be the depth at which the clear coat would be expected to have the least possible degradation. In order to observe the changes in UV absorber concentration through a layer, spectra were taken from closest to the color coat and moving outwards towards the environment (*Figure 4*).

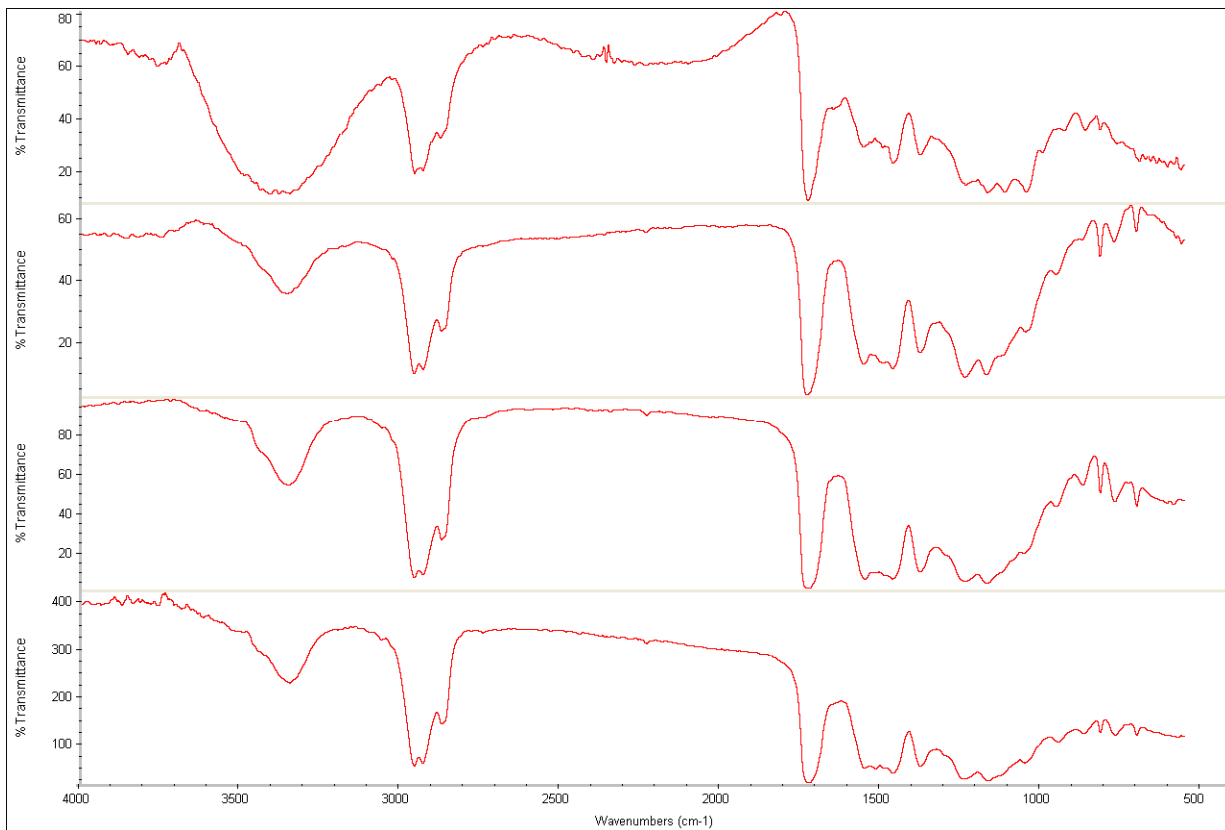
Figure 5 – IR Data collected at the NWAFS Fall 2011 Meeting. This set includes (from top to bottom) 2000, 2002, 2003, and 2004.

Analysis using the methodology described above is quick, efficient, and allows the same sample to be used with different techniques. The data from the Fall Meeting display consistency in the IR spectra (Figures 5 and 6). Although there are slight differences present in the IR spectra of the different samples, they are not substantive enough to

eliminate one sample from another during comparison based on only having a single spectrum for each. It may have been possible to account for the variances in the transmission line and possible contributions of components from the color coat with additional data collection as well as discriminate between samples with adequate replicates, but this was not possible within the time constraints.

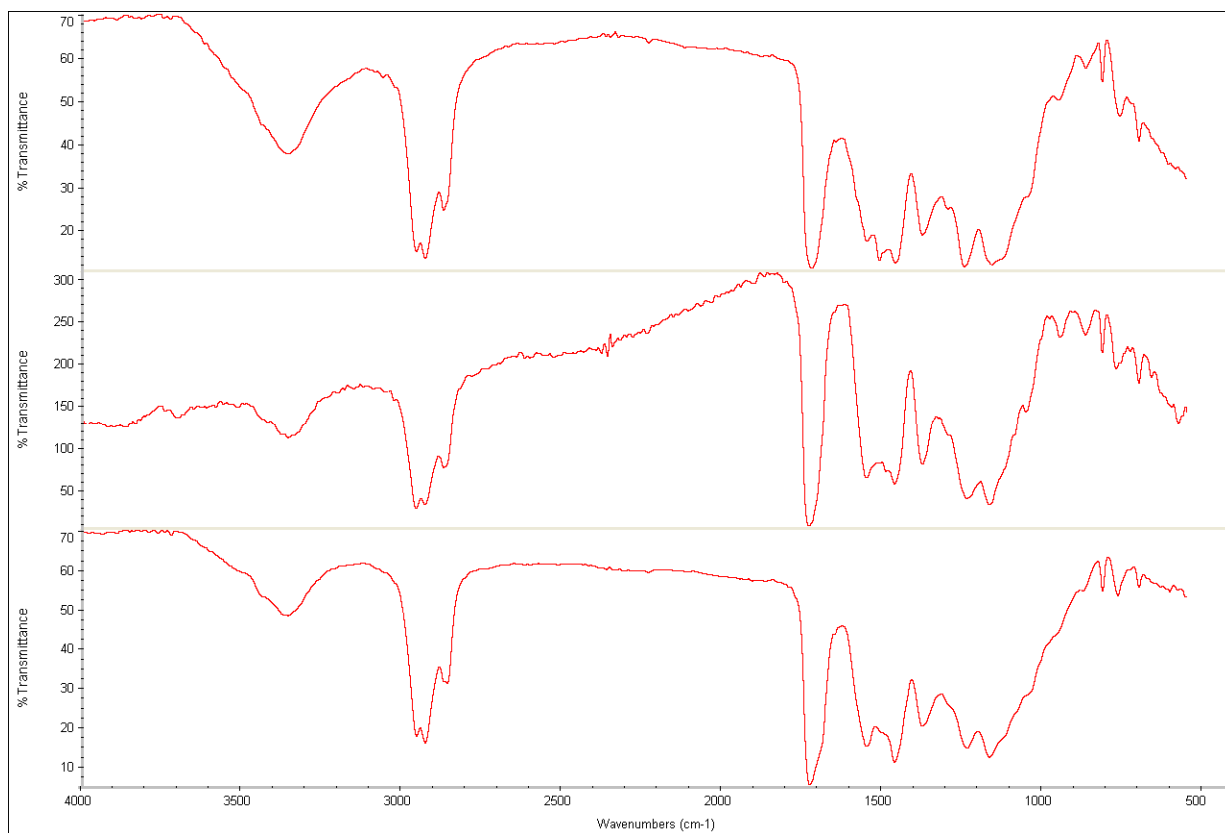
Figure 6 – IR Data collected at the NWAFS Fall 2011 Meeting. This set includes (from top to bottom) 2005, 2007, and 2008.

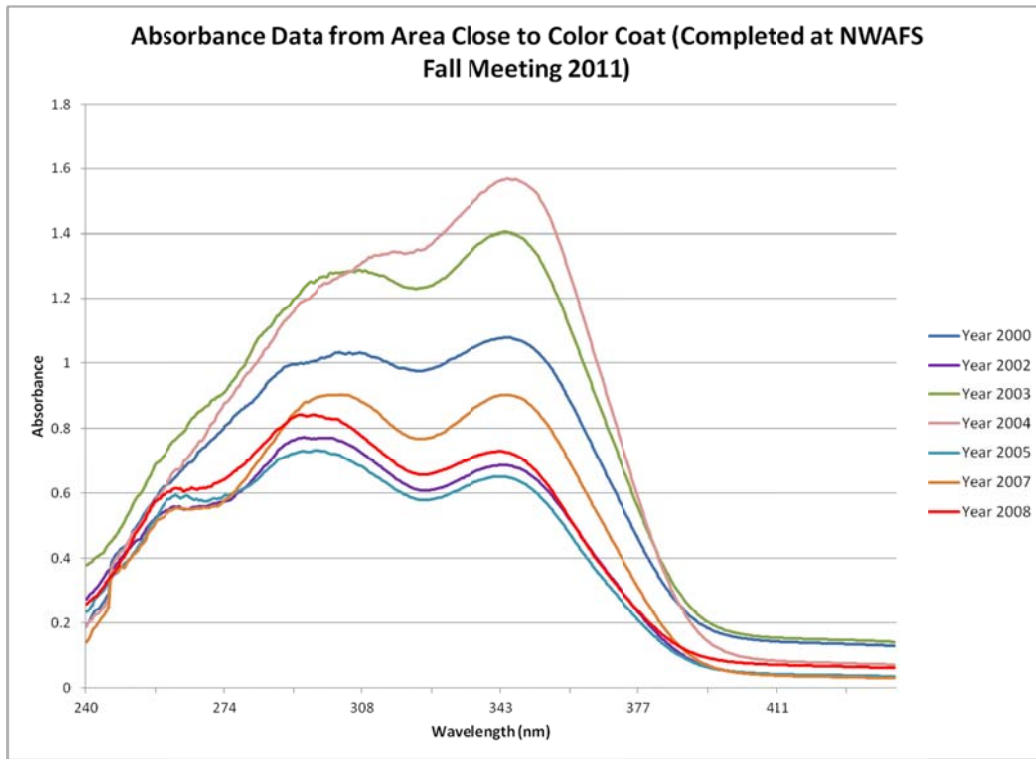
Figure 7 – MSP Data taken at Spot 1 at the NWAFS Fall 2011 Meeting taken close to the color coat.

The MSP data display a similar trend. The different years display a consistency in peak shape and peak location. Variation in absorbance is due to the similar components having different relative concentrations (Figure 7).

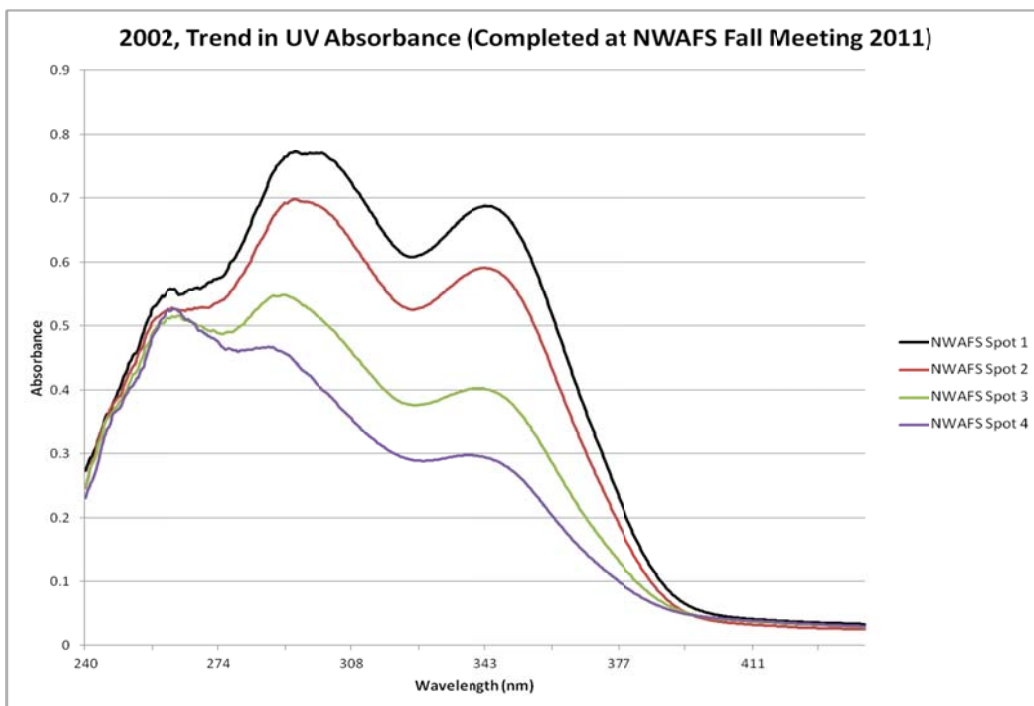
Figure 8 – Data for the 2002 sample taken at the NWAFS Fall 2011 Meeting. Data were from closest to the color coat (Spot 1) to closest to the environment (Spot 4). The degradation of the UV absorbers in the clear coat is shown by the decrease in the absorbance values.

There is a decrease in the amount of UV absorption throughout a clear coat layer. This was first measured during the Fall Meeting in the sample from 2002 (Figure 8). Subsequent to the Fall meeting the samples were retested by sampling four points in the clear coat as previously described. A decrease in UV absorption through a clear coat layer was produced for each year. Examples of the degradation include the 2002 data (same sample as the NWAFS data) and the 2000 data (Figures 9 and 10).

The data shows a decrease in UV absorption in a clear coat as the sampling area is moved closer to the environment rather than the color coat. This trend is due to the interaction of sunlight with the UV absorbers previously discussed.⁴ Although it may be expected that a starker decrease in UV absorbers should be seen in 2000 than in later years, this will not always be the case due to factors such as the environment which the car was used in and the amount of time the vehicle was in service.

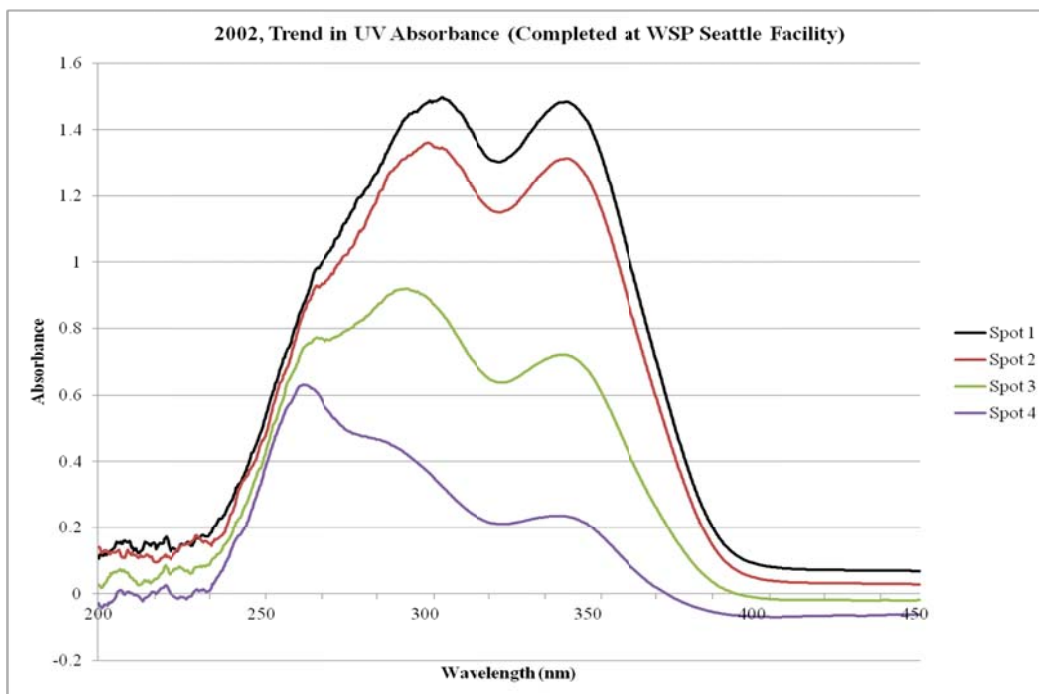
Figure 9 – Data for the 2002 sample taken at the WSP Seattle Crime Lab. Data were from closest to the color coat (Spot 1) to closest to the environment (Spot 4).

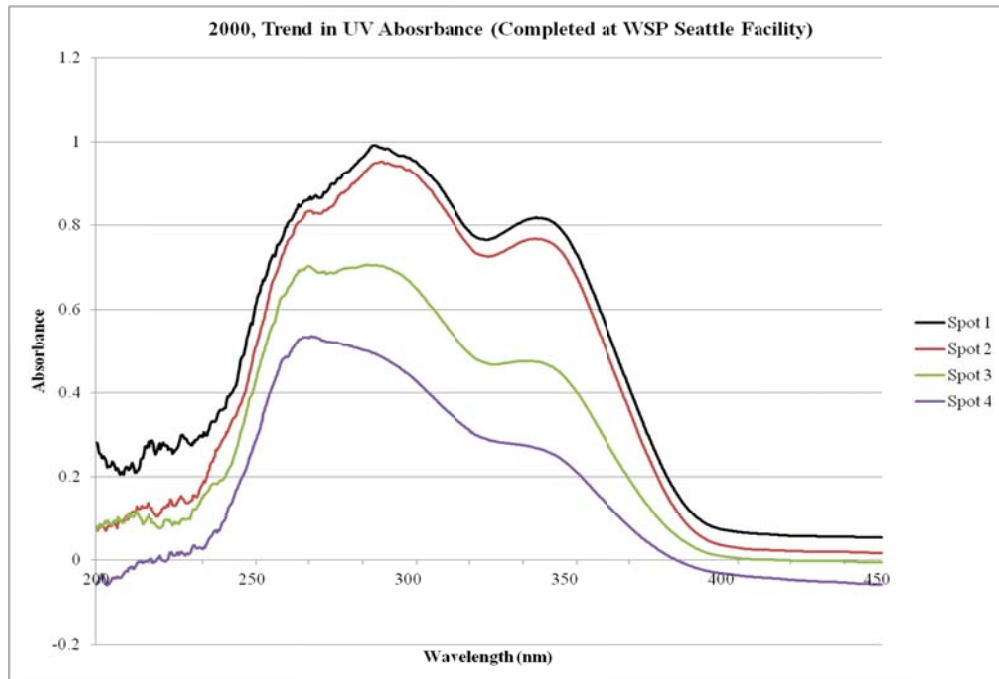
Figure 10 – Data for the 2000 sample taken at the WSP Seattle Crime Lab. Data were from closest to the color coat (Spot 1) to closest to the environment (Spot 4).
